# 7.1 Operation Tests

## 7.1.1 Self-diagnosis function (self test)

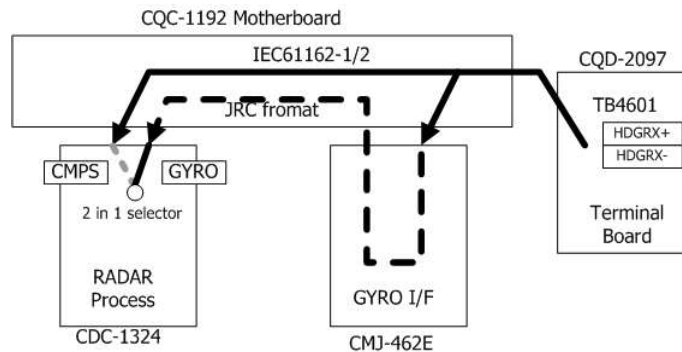
The diagram above shows the routes of signals output using IEC61162-1/2. If the azimuth sensor shows CMPS, the output signal from the external equipment is input directly to the radar process circuit. If it shows "GYRO", the output signal is input to the radar process circuit in JRC format via the GYRO I/F circuit. If the connection settings are correct, the azimuth is correctly displayed whichever mode is switched to.

If the azimuth is not displayed by switching between CMPS and GYRO, the settings are not correct. For the GYRO I/F circuit it is necessary to set the DIP-SW and jumper. If CMPS is selected, check the baud rates shown below.
